Contract #: 04-0120F4Cty: SF/ALA Rte: 80 PM: 13.2/13.9File #: 13.28**WELDING INSPECTION REPORT****Resident Engineer:**Pursell, Gary**Address:** 333 Burma Road**City:** Oakland, CA 94607**Report No:** WIR-013464**Date Inspected:** 28-Apr-2010**Project Name:** SAS Superstructure**OSM Arrival Time:** 1000**Prime Contractor:** American Bridge/Fluor Enterprises, a JV**OSM Departure Time:** 1830**Contractor:** Oregon Iron Works Clackamas, Or.**Location:** Clackamas, OR

CWI Name:	M. Gregson, J. Salazar, G. Mundt			CWI Present:	Yes	No
Inspected CWI report:	Yes	No	N/A	Rod Oven in Use:	Yes	No N/A
Electrode to specification:	Yes	No	N/A	Weld Procedures Followed:	Yes	No N/A
Qualified Welders:	Yes	No	N/A	Verified Joint Fit-up:	Yes	No N/A
Approved Drawings:	Yes	No	N/A	Approved WPS:	Yes	No N/A
				Delayed / Cancelled:	Yes	No N/A
Bridge No:	34-0006			Component:	Hinge K Pipe Beams

Hinge-K Pipe Beam Assembly 101A-3:

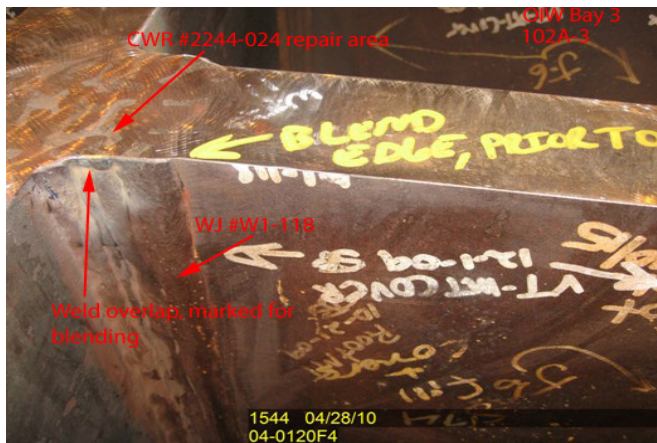
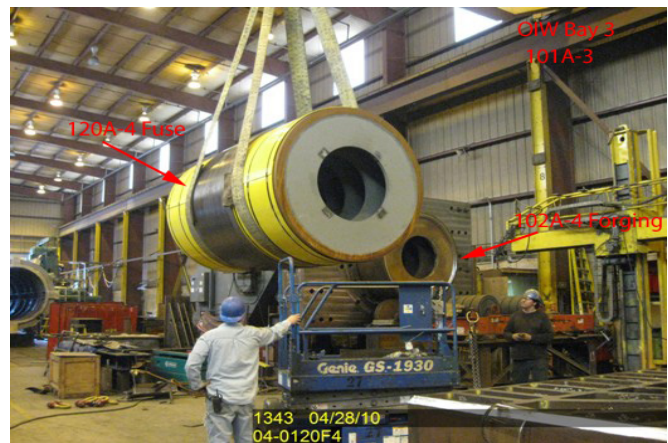
The QA Inspector observed Production Lead Troy Smith and WID #B62 (Marcus Belgarde) attaching 2 slings around the Fuse 120A-4. Lead Troy Smith explained to the QA Inspector that the slings were being attached, in preparation for lifting the Fuse and placing on the mechanical rollers. Once the slings were around the Fuse, the QA Inspector observed WID #B62, utilizing the hand held control box for the overhead shop bay crane, to lower the lifting cable and attached hook. The QA Inspector then observed Lead Troy Smith attaching the previously placed slings to the hook. The QA Inspector then witnessed WID #B62 utilizing the hand held control box, to operate the shop crane and gradually lift the Fuse from the shop floor. While the Fuse was being lifted, the QA Inspector observed Lead Troy Smith handling the Fuse to control the movement, during the lifting. The QA Inspector then observed the Fuse being gradually guided to a stationary set of previously placed mechanical rollers. The QA Inspector noted that this Fuse was being placed, for the fit-up to Forging assembly 102A-4. Once the Fuse was in place above the stationary set of rollers, the QA Inspector then witnessed WID #B62, utilize the hand held control to gradually lower the Fuse on the set of rollers. Once set on the rollers, the QA Inspector observed Lead Troy Smith and WID #B62, gradually guide the Fuse to the Forging, to start fitting up the weld joint. The QA Inspector noted that this weld joint is designated as an AWS D1.5 Complete Joint Penetration (CJP) B-U7-S. Lead Troy Smith explained to the QA Inspector that the fit-up will continue to the end of this shift and will probably not

start tack welding the joint, until the following day, 4-29-10. Lead Troy Smith explained that OIW QC personell will be notified, prior to the tack welding. Per the contract requirements, OIW QC personell are required to inspect the fit-up before welding the joint. See attached pictures below.

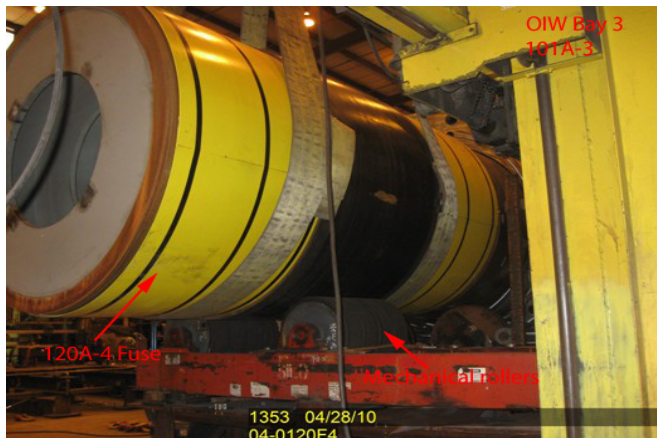
The QA Inspector was informed by OIW QC Inspector Jose' Salazar that informal Visual and Magnetic Particle testing (VT/MT) had been performed on the critical Weld Repair (CWR #2244-024), weld joints #W1-118 and #W1-103. QC Inspector Salazar explained that no rejectable indications were found, during the informal testing. QC Inspector Salazar then explained that the final MT will be performed on swing shift, by QC Inspector Gary Mundt.

The QA Inspector was present on this swing shift and performed visual testing on the CWR #2244-024, weld joint # W1-118 and #W1-103. The QA Inspector found no rejectable indications on the weld joint #W1-103. The QA Inspector discovered weld overlap on the weld joint #W1-118, near the weld termination of the joint. The QA Inspector marked the area for grinding and blending on the part, with a yellow paint marker. The QA Inspector then informed OIW QC Inspector Gary Mundt that the area will need grinding, prior to the final MT being performed. QC Inspector Mundt explained that if he performs the final VT/MT on these weld joint, that he will notify production personell to perform the grinding. See attached picture below.
